Manhole Inspection Summary

Manhole # S27Y__012MH

Insp Date: 1/14/09 9:48 AM

Location Address: **Annapolis Rd.**

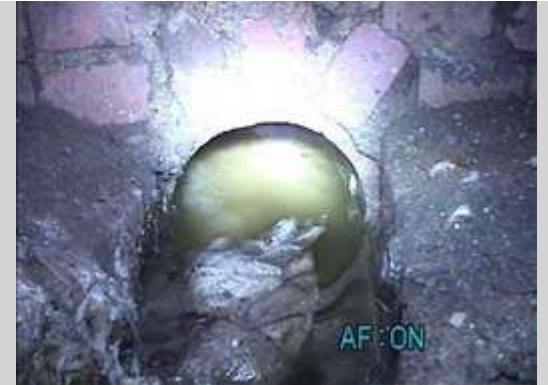
12 O'Clock Outflow

8 in. Circular Gravity Sewer
Pipe Out @ 12 O'Clock

Deposits: ☒ None ☐ Mud ☐ Sludge ☐ Debris ☐ Grease

Infiltration: None Pipe Seal Cond: Sound

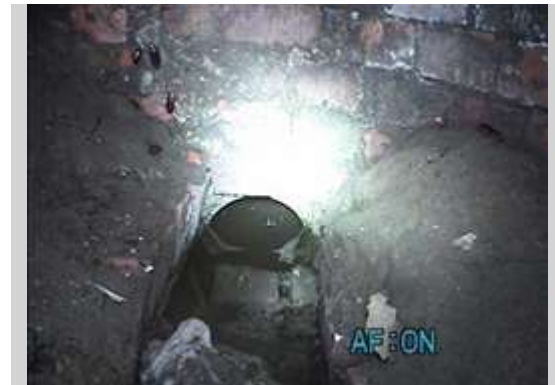
Drop In @ 8 O'Clock

Deposits: ☐ None ☐ Mud ☐ Sludge ☒ Debris ☐ Grease

Silt Depth: 3 (in.) Deposits Extent: Medium

Drop: Outside Direct

Drop Condition: Open
